**Flood Control Project Maintenance
Levee Inspections**

Fall 2009 Levee Maintenance Deficiency Summary Report

American River Flood Control District

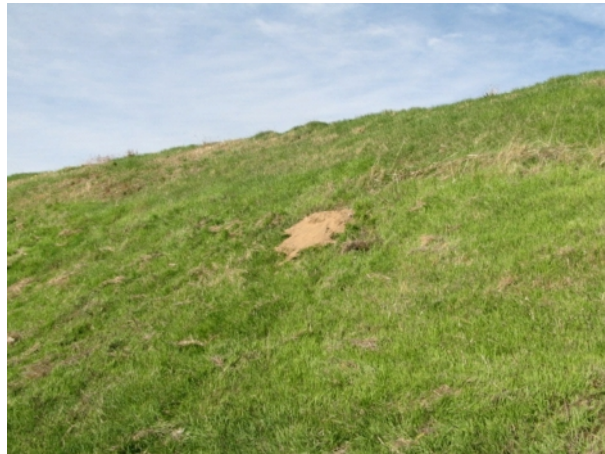
jpaasch_20091029_116.jpg

Photo of active rodent hole near LM 0.10

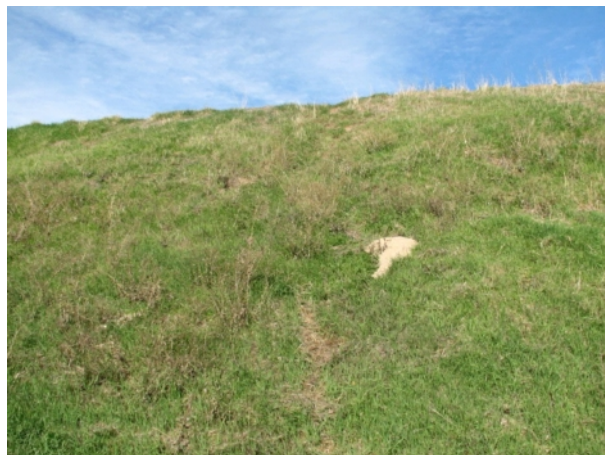
Levee Mile Report Line	3
Start Levee Mile	0.19
End Levee Mile	0.19
Location	Land Side
Category	Earthen Levee
Item	Animal Control

Photo of active rodent hole near LM 0.19

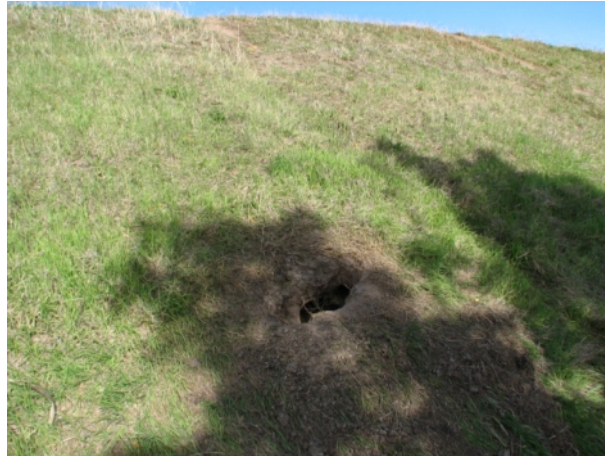
jpaasch_20091029_114.jpg

Photo of active rodent hole near LM 0.22.

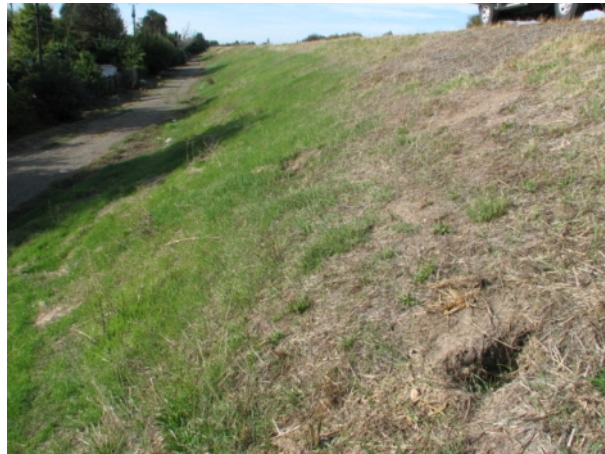
Levee Mile Report Line	5
Start Levee Mile	0.46
End Levee Mile	0.46
Location	Land Side
Category	Earthen Levee
Item	Animal Control

Photo of active rodent holes near LM 0.46.

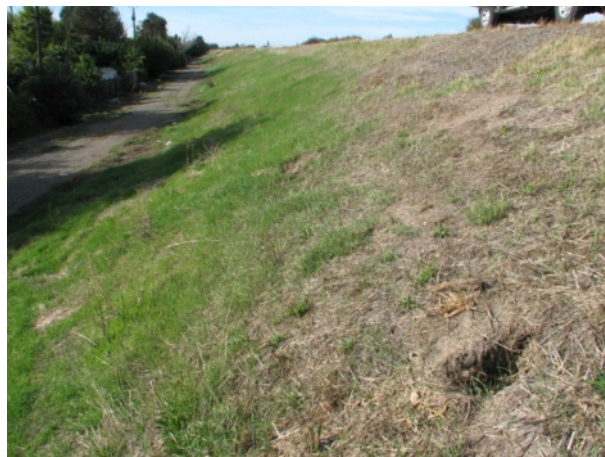
Levee Mile Report Line	6
Start Levee Mile	0.57
End Levee Mile	0.57
Location	Land Side
Category	Earthen Levee
Item	Animal Control

Photo of rodent holes near LM 0.57.

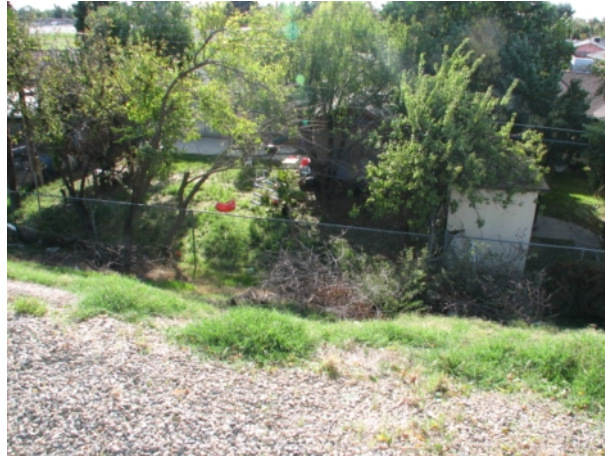
jpaasch_20091029_109.jpg

Photo of prunings left on levee slope.

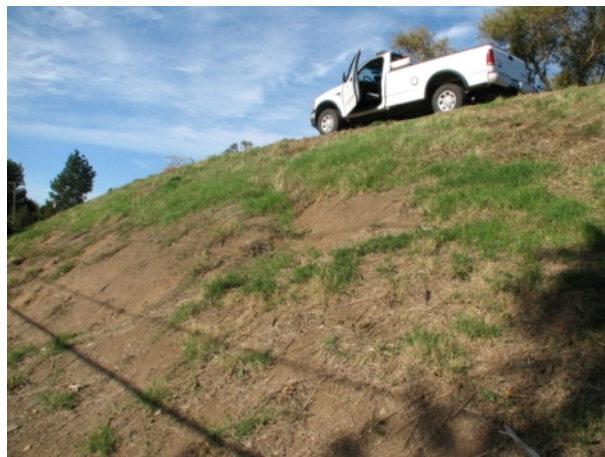
jpaasch_20091029_111.jpg

Photo of levee slope damage caused by foot traffic.

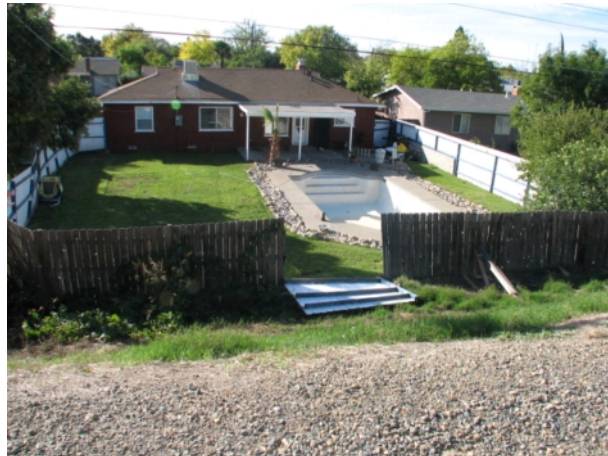
jpaasch_20091029_107.jpg

Photo of damaged wooden fence.

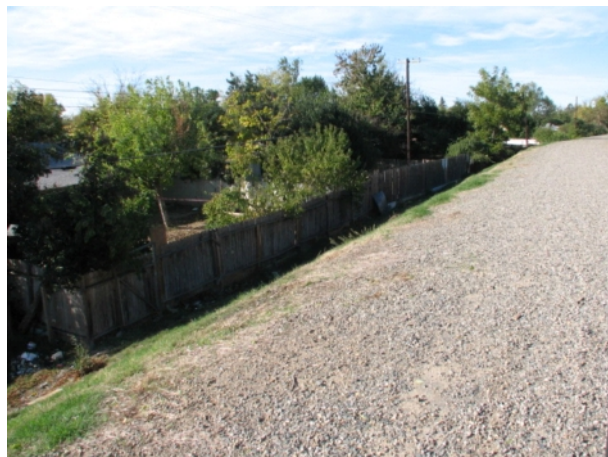
Levee Mile Report Line	17
Start Levee Mile	1.19
End Levee Mile	1.19
Location	Land Side
Category	Earthen Levee
Item	Encroachments

Photo of solid fences built against the levee slope.

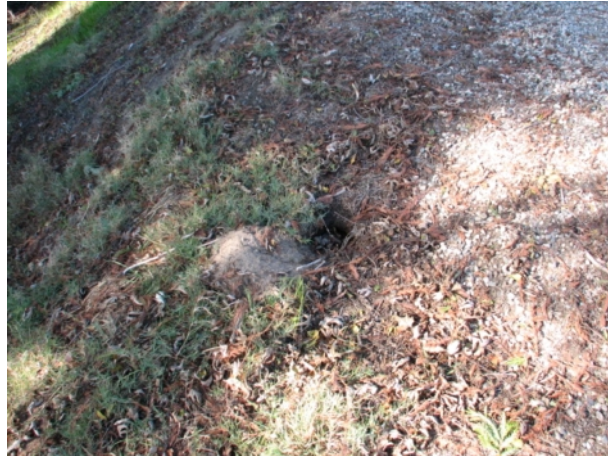
jpaasch_20091029_105.jpg

Photo of animal burrow on crown at landside hinge point.

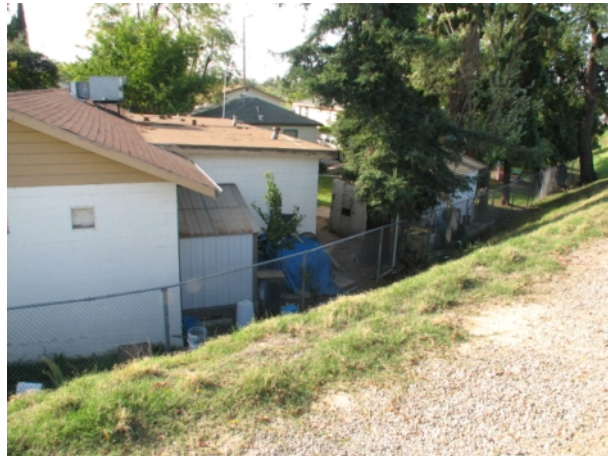
Levee Mile Report Line	19
Start Levee Mile	1.26
End Levee Mile	1.26
Location	Land Side
Category	Earthen Levee
Item	Encroachments

Photo of buildings and fence near levee toe.

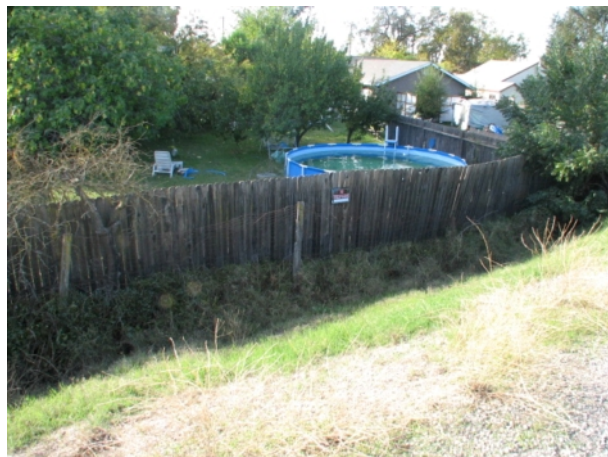
Levee Mile Report Line	22
Start Levee Mile	1.38
End Levee Mile	1.38
Location	Land Side
Category	Earthen Levee
Item	Encroachments

Wooden and wire fence are within 10-ft of levee toe.

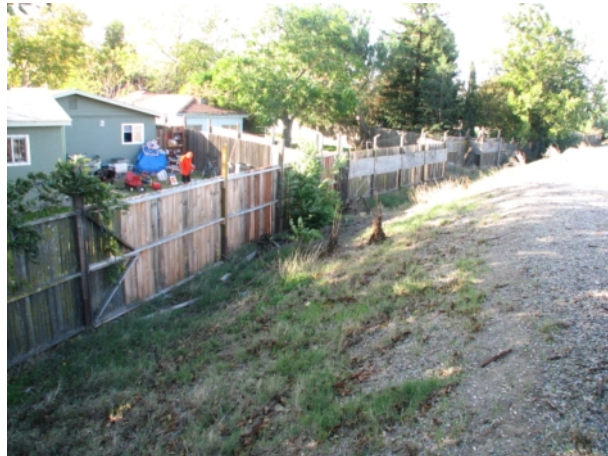
Levee Mile Report Line	26
Start Levee Mile	1.42
End Levee Mile	1.42
Location	Land Side
Category	Earthen Levee
Item	Encroachments

26	1.42	1.42	Earthen Levee	Encroachments	LS	CO	Fences Inspector Comments: Dog-eared wooden fence is built near the levee slope.	38.626212 ° -121.444082 °	38.626212 ° -121.444082 °	12 Y
27	1.43	1.43	Earthen Levee	Slope Stability	LS	M	Repair slope instability. Inspector Comments: 12" DIA hole on hinge point	38.626419 ° -121.443842 °	38.626419 ° -121.443842 °	37 Y
28	1.43	1.43	Earthen Levee	Encroachments	LS	CO	Landscaping Inspector Comments: Brush near apartment mattresses.	38.626325 ° -121.443928 °	38.626325 ° -121.443928 °	11 Y

Photo of wooden fence built near levee slope.

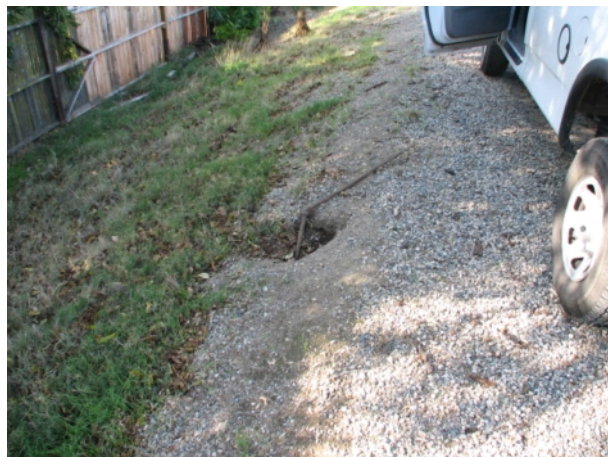
Levee Mile Report Line	27
Start Levee Mile	1.43
End Levee Mile	1.43
Location	Land Side
Category	Earthen Levee
Item	Slope Stability

Photo of hole on landside hinge point.

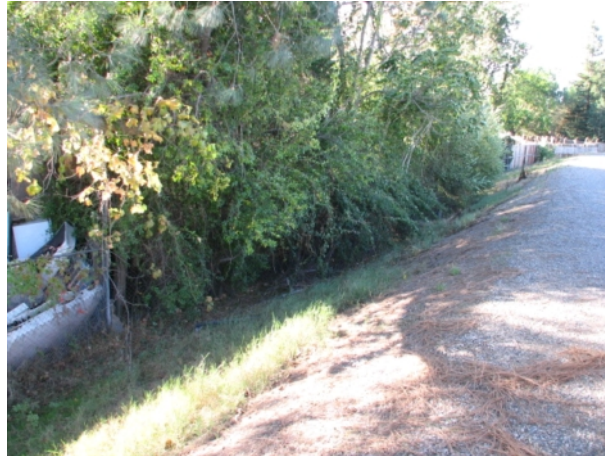
jpaasch_20091029_99.jpg

Brush completely blocks visibility and access to the levee slope and toe.

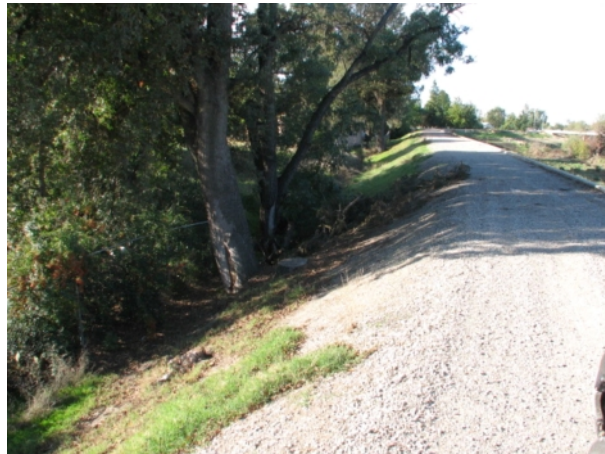
Levee Mile Report Line	29
Start Levee Mile	1.50
End Levee Mile	1.50
Location	Land Side
Category	Earthen Levee
Item	Encroachments

Photo of downed tree limb on levee slope.

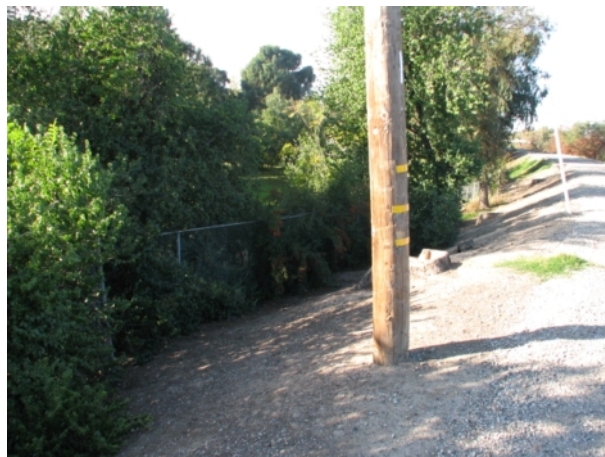
Levee Mile Report Line	30
Start Levee Mile	1.54
End Levee Mile	1.54
Location	Land Side
Category	Earthen Levee
Item	Encroachments

Photo of vegetation obstructing visibility near levee slope.

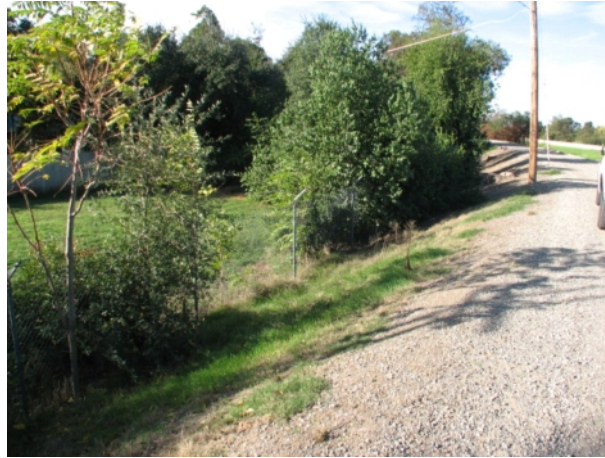
jpaasch_20091029_97.jpg

Photo of Photinias and other plants planted near levee toe.

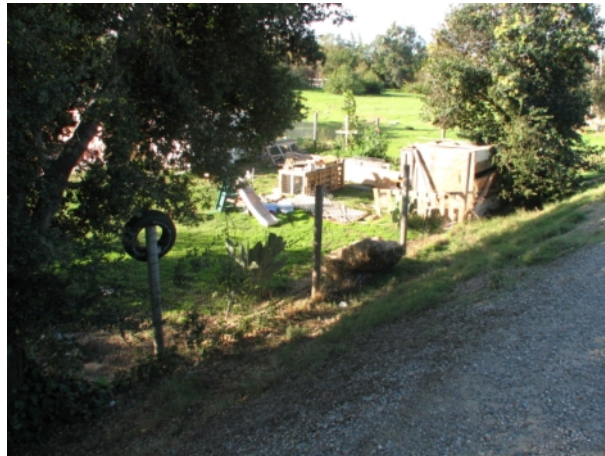
Levee Mile Report Line	32
Start Levee Mile	1.82
End Levee Mile	1.82
Location	Land Side
Category	Earthen Levee
Item	Encroachments

Photo of wooden animal shelter and vegetation near levee slope.

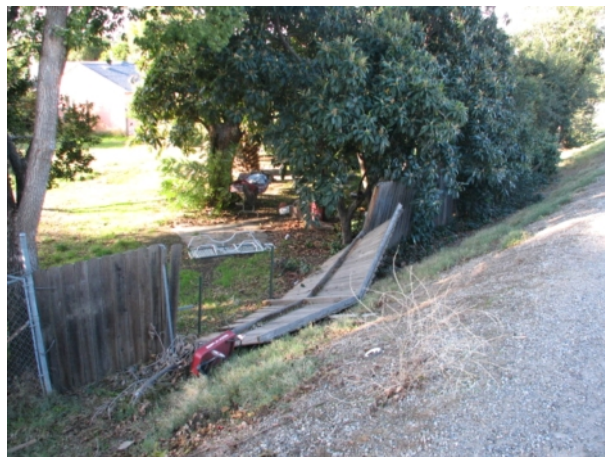
Levee Mile Report Line	33
Start Levee Mile	1.83
End Levee Mile	1.83
Location	Land Side
Category	Earthen Levee
Item	Encroachments

Photo of partially obstructive vegetation and fence.

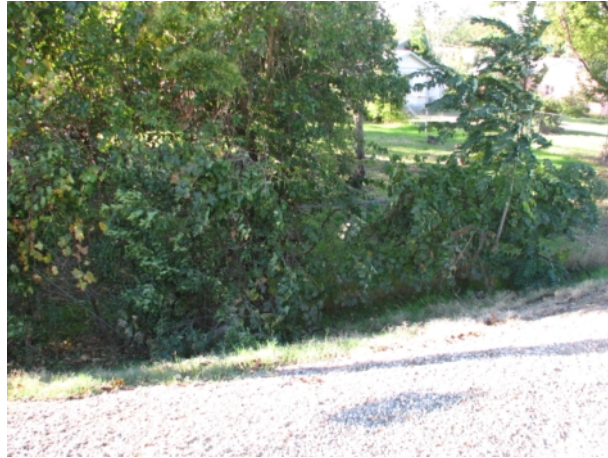
jpaasch_20091029_93.jpg

Grapevine and brush growing on fence near the levee toe. Visibility and access are obstructed.

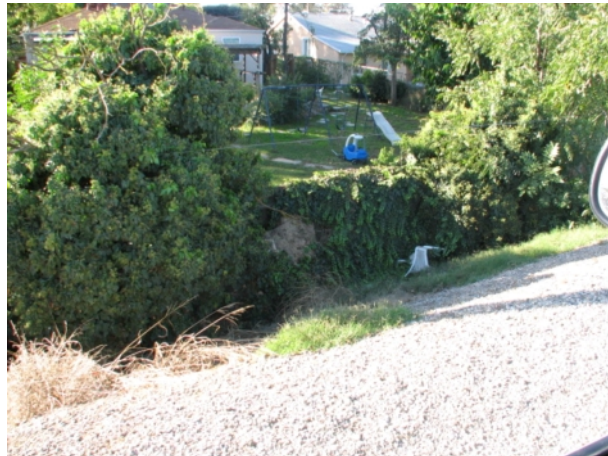
Levee Mile Report Line	35
Start Levee Mile	1.87
End Levee Mile	1.87
Location	Land Side
Category	Earthen Levee
Item	Encroachments

Photo of vegetation growing on wooden fence.

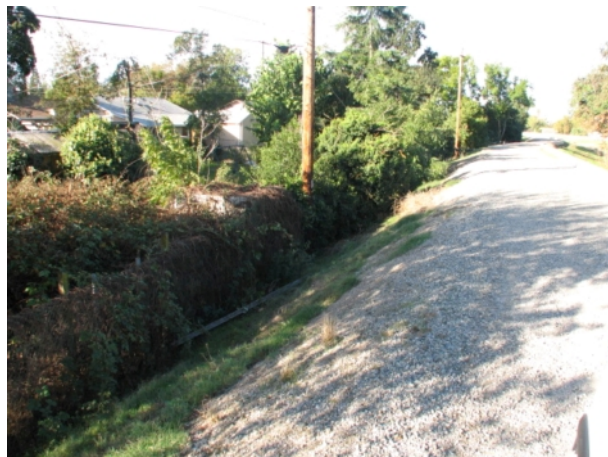
Levee Mile Report Line	36
Start Levee Mile	1.88
End Levee Mile	1.88
Location	Land Side
Category	Earthen Levee
Item	Encroachments

Metal sided shed covered with brush is built near levee toe.

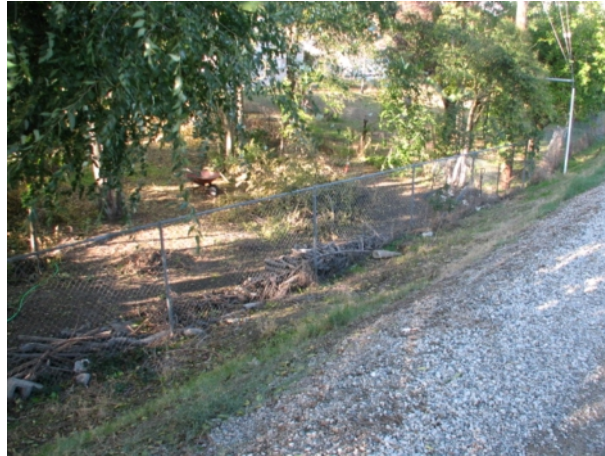
jpaasch_20091029_90.jpg

Wood and debris is piled near levee toe.

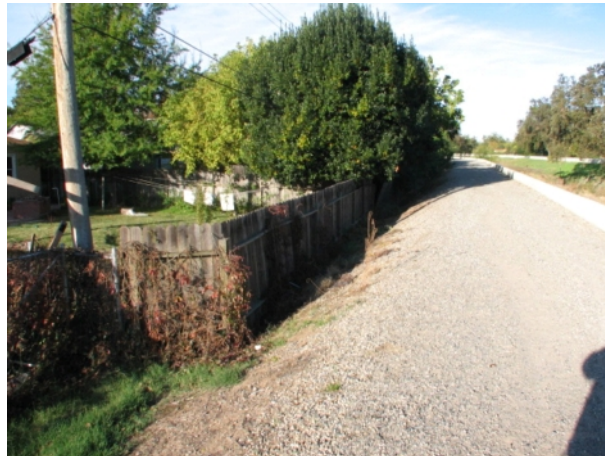
Levee Mile Report Line	41
Start Levee Mile	1.95
End Levee Mile	1.95
Location	Land Side
Category	Earthen Levee
Item	Encroachments

Wooden fence built on levee slope.

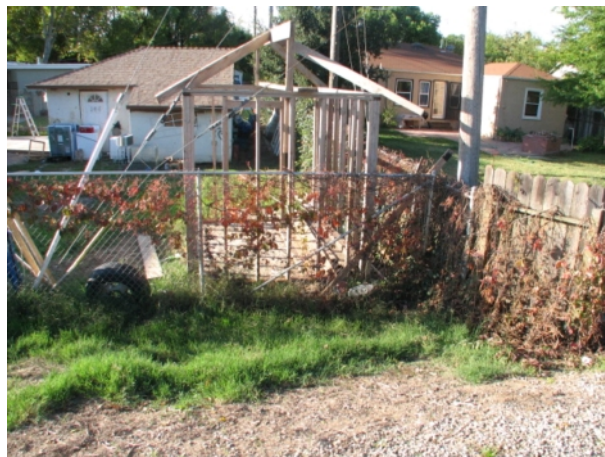
Levee Mile Report Line	42
Start Levee Mile	1.95
End Levee Mile	1.95
Location	Land Side
Category	Earthen Levee
Item	Encroachments

Photo of building being built near levee toe.

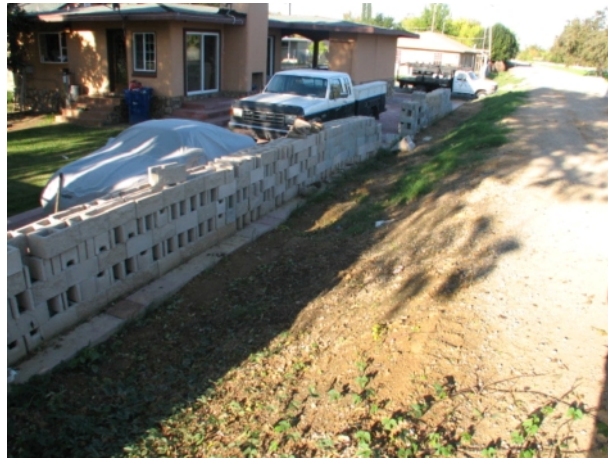
jpaasch_20091029_87.jpg

Photo of cement blocks placed on concrete pad at levee toe.

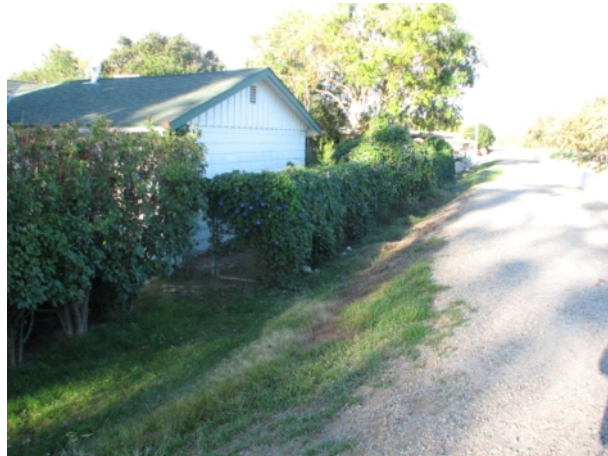
Levee Mile Report Line	44
Start Levee Mile	2.00
End Levee Mile	2.00
Location	Land Side
Category	Earthen Levee
Item	Encroachments

Photo of vines on fence. Visibility and access are limited.

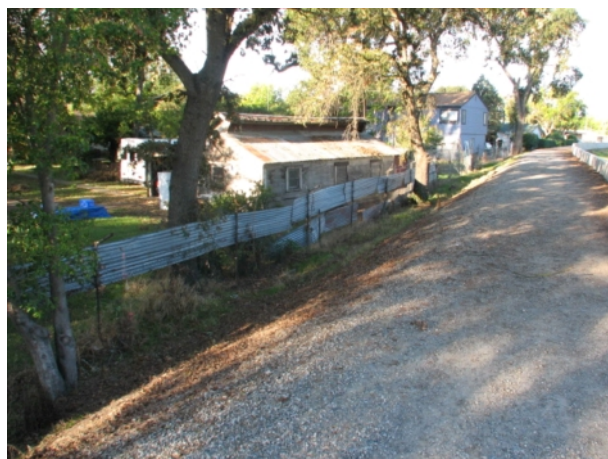
Levee Mile Report Line	46
Start Levee Mile	2.05
End Levee Mile	2.05
Location	Land Side
Category	Earthen Levee
Item	Encroachments

Photo of building within 10-ft of levee toe. Fence is partially obstructive.

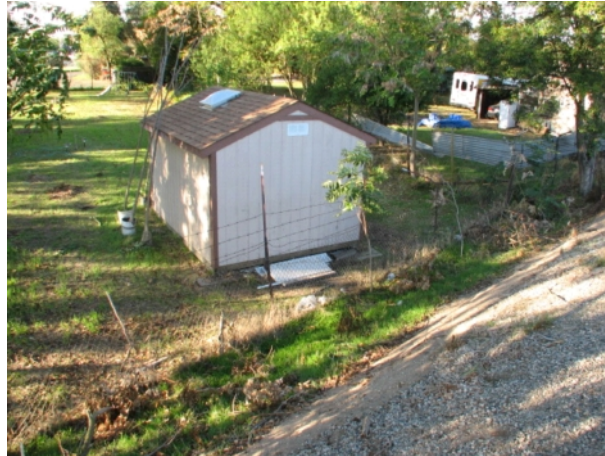
jpaasch_20091029_84.jpg

Photo of building within 10-ft of levee toe.

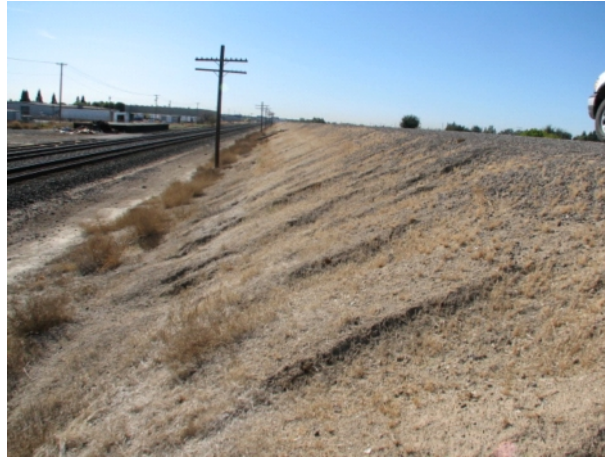
jpaasch_20091002_3.jpg

Photo showing eroded slope.

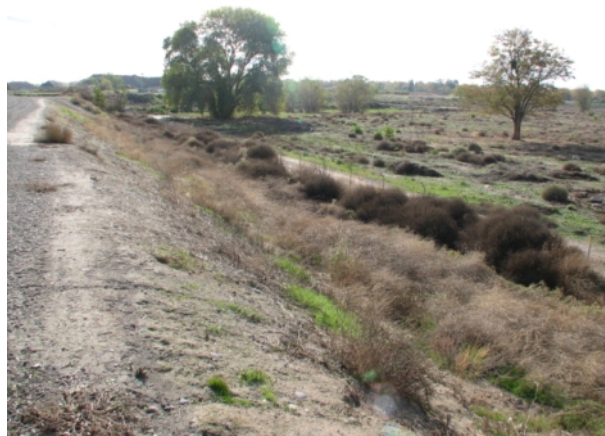
Levee Mile Report Line	7
Start Levee Mile	2.40
End Levee Mile	2.45
Location	Land Side
Category	Earthen Levee
Item	Vegetation
Photo of minimally acceptable vegetation on landside slope and toe. Annual maintenance was not done due to concerns for the "tent city" which was located here.	
jpaasch_20091109_195.jpg

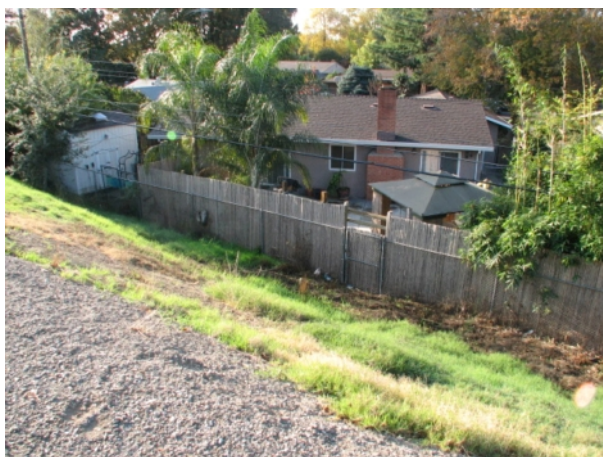
Levee Mile Report Line	14
Start Levee Mile	3.88
End Levee Mile	3.88
Location	Land Side
Category	Earthen Levee
Item	Encroachments
Fence and landscaping within 10-ft of levee toe obstructs access and visibility.	
jpaasch_20091116_207.jpg

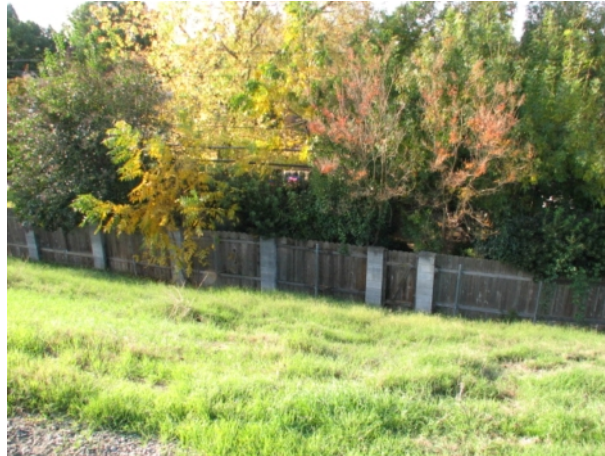
Levee Mile Report Line	25
Start Levee Mile	4.02
End Levee Mile	4.02
Location	Land Side
Category	Earthen Levee
Item	Encroachments
Fence and landscaping within 10-ft of levee toe obstructs access and visibility.	
jpaasch_20091116_212.jpg

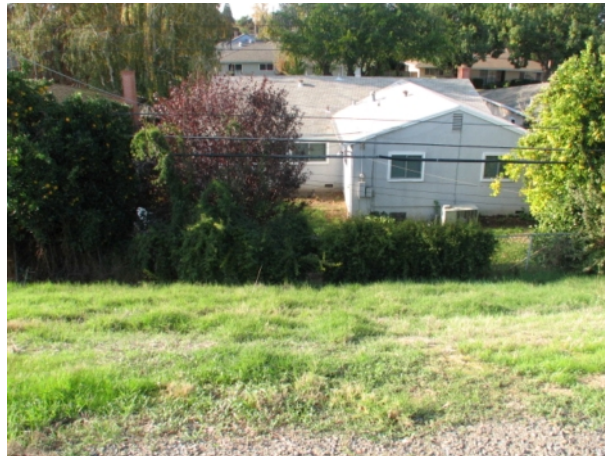
Levee Mile Report Line	29
Start Levee Mile	4.08
End Levee Mile	4.08
Location	Land Side
Category	Earthen Levee
Item	Encroachments
Landscaping within 10-ft of levee toe obstructs access and visibility.	
jpaasch_20091116_213.jpg

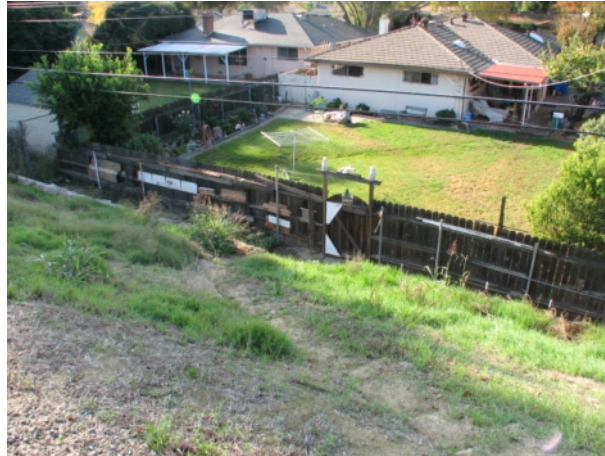
Levee Mile Report Line	39
Start Levee Mile	4.21
End Levee Mile	4.21
Location	Land Side
Category	Earthen Levee
Item	Encroachments
Fence and retaining wall built within 10-ft of levee toe.	
jpaasch_20091116_216.jpg

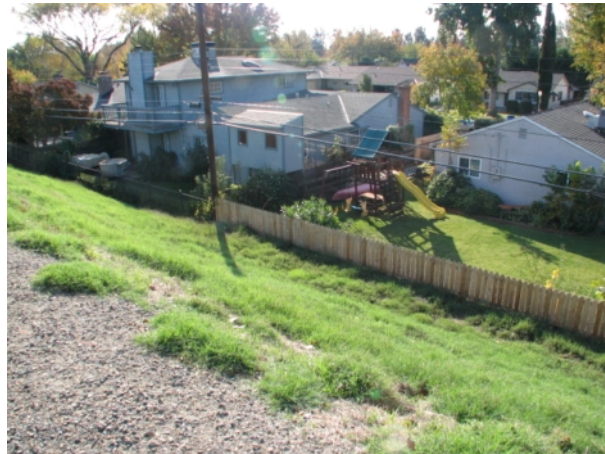
Levee Mile Report Line	49
Start Levee Mile	4.37
End Levee Mile	4.37
Location	Land Side
Category	Earthen Levee
Item	Encroachments
Fence within 10-ft of levee toe obstructs access and visibility.	
jpaasch_20091116_215.jpg

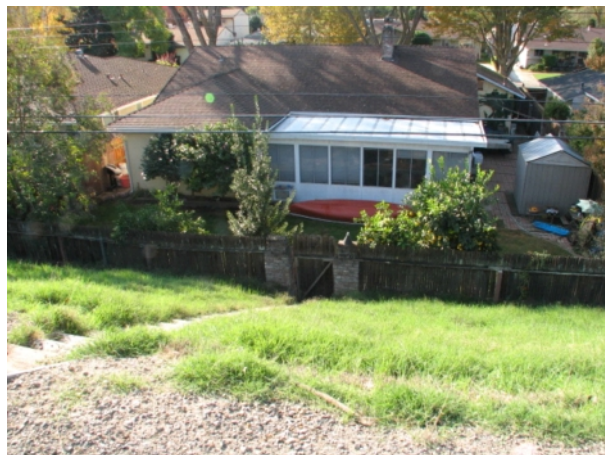
Levee Mile Report Line	52
Start Levee Mile	4.41
End Levee Mile	4.41
Location	Land Side
Category	Earthen Levee
Item	Encroachments
Fence within 10-ft of levee toe obstructs access and visibility.	
jpaasch_20091116_217.jpg

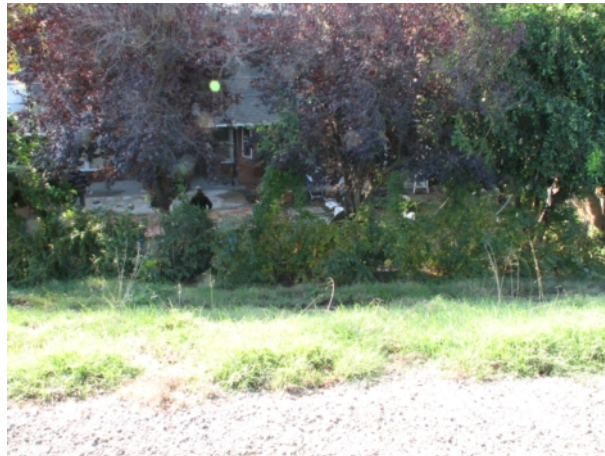
Levee Mile Report Line	62
Start Levee Mile	4.65
End Levee Mile	4.65
Location	Land Side
Category	Earthen Levee
Item	Encroachments
Landscaping within 10-ft of levee toe obstructs access and visibility.	
jpaasch_20091116_219.jpg

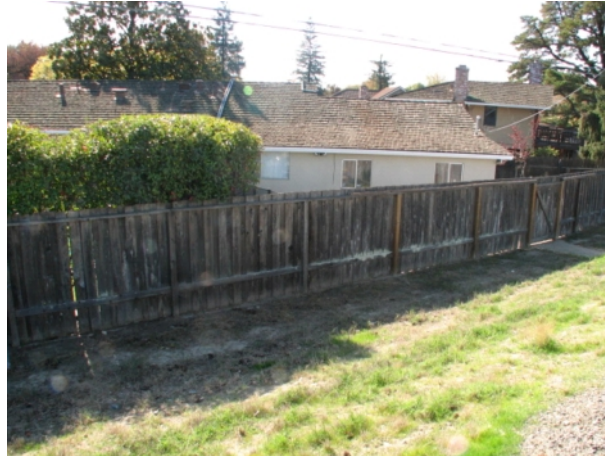
Levee Mile Report Line	78
Start Levee Mile	5.08
End Levee Mile	5.08
Location	Land Side
Category	Earthen Levee
Item	Encroachments
Fence and landscaping within 10-ft of levee toe obstructs access and visibility.	
jpaasch_20091116_221.jpg

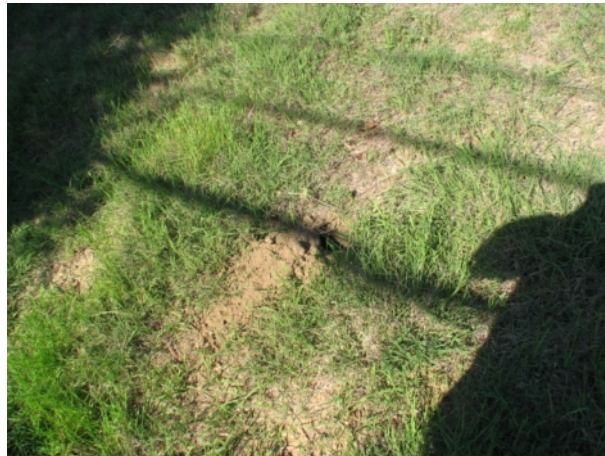
Levee Mile Report Line	80
Start Levee Mile	5.11
End Levee Mile	5.11
Location	Water Side
Category	Earthen Levee
Item	Animal Control
Animal burrow on the bottom of waterside slope.	
jpaasch_20091116_229.jpg

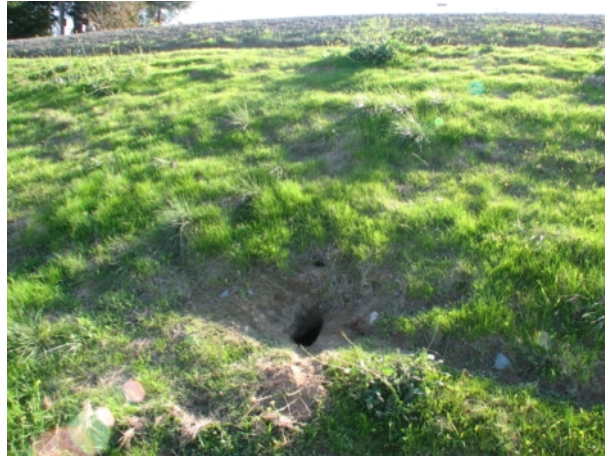
jpaasch_20091116_228.jpg

Large animal burrow on waterside slope.

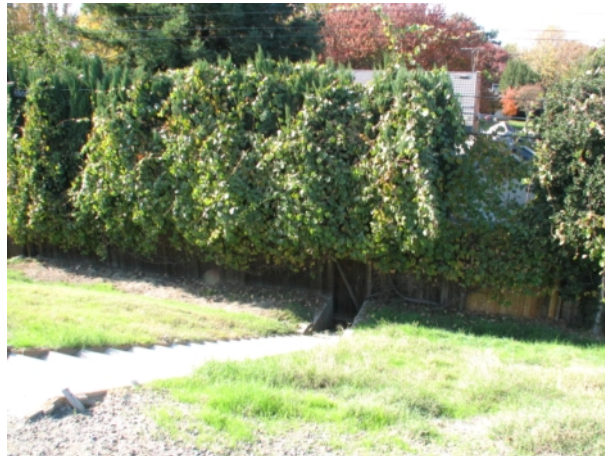
jpaasch_20091116_223.jpg

Levee Mile Report Line	90
Start Levee Mile	5.63
End Levee Mile	5.63
Location	Land Side
Category	Earthen Levee
Item	Encroachments

Fence and landscaping within 10-ft of levee toe obstructs access and visibility.

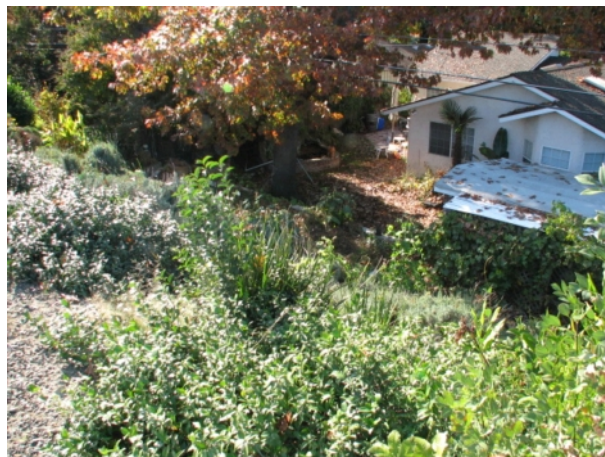
jpaasch_20091116_224.jpg

Levee Mile Report Line	107
Start Levee Mile	5.89
End Levee Mile	5.89
Location	Land Side
Category	Earthen Levee
Item	Encroachments

Landscaping on and within 10-ft of levee slope obstructs access and visibility.

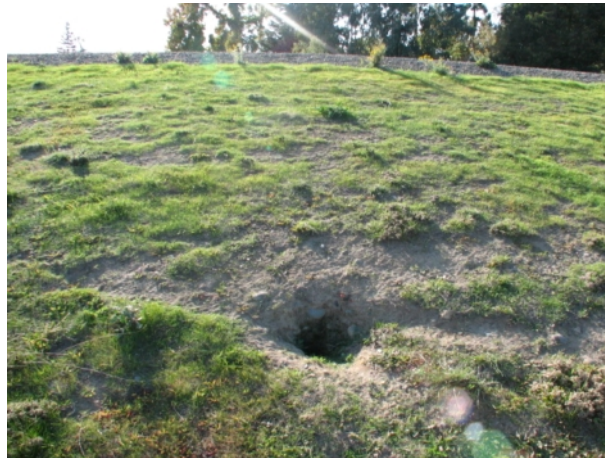
jpaasch_20091116_227.jpg

Large animal burrow on the waterside slope.

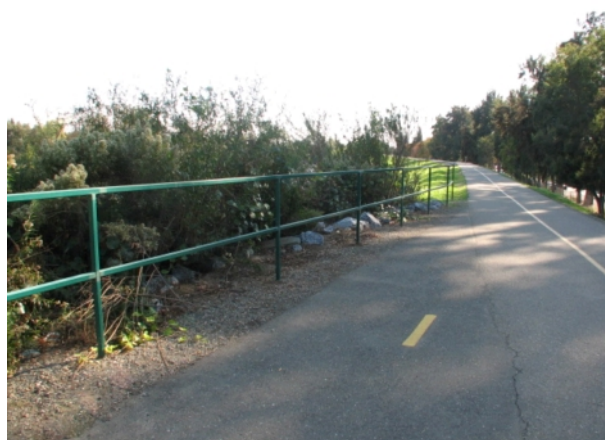
jpaasch_20091116_225.jpg

Levee Mile Report Line	114
Start Levee Mile	6.15
End Levee Mile	6.15
Location	Water Side
Category	Earthen Levee
Item	Vegetation

Vegetation near levee crown obstructs visibility and access.

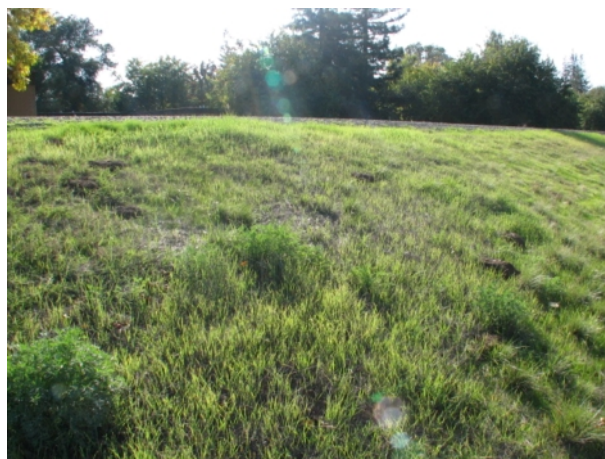
jpaasch_20091116_226.jpg

Levee Mile Report Line	116
Start Levee Mile	7.29
End Levee Mile	7.29
Location	Water Side
Category	Earthen Levee
Item	Animal Control

Rodent activity present on levee slope. Photo of several animal burrows.

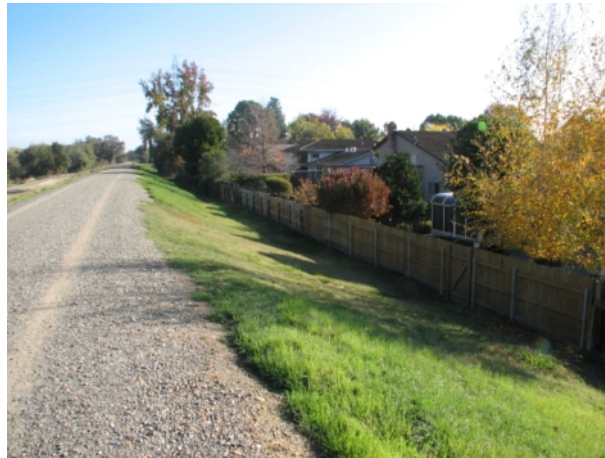
jpaasch_20091119_240.jpg

Privacy fence is within 10-ft of landside levee toe.

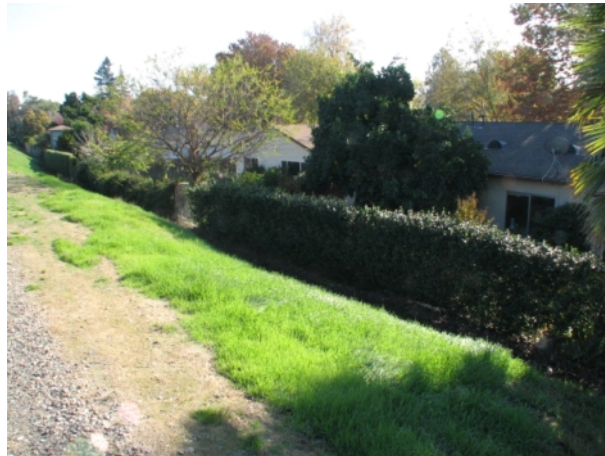
jpaasch_20091119_238.jpg

Levee Mile Report Line	167
Start Levee Mile	8.61
End Levee Mile	8.61
Location	Land Side
Category	Earthen Levee
Item	Encroachments

Hedge on the levee toe obstructs visibility.

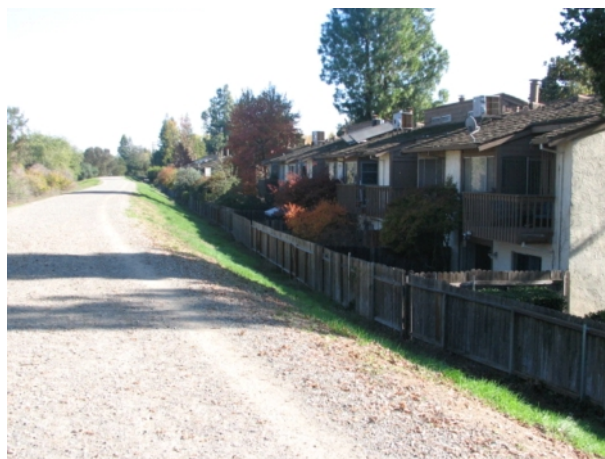
jpaasch_20091119_236.jpg

Levee Mile Report Line	203
Start Levee Mile	10.38
End Levee Mile	10.40
Location	Land Side
Category	Earthen Levee
Item	Encroachments

Privacy fence within 10-ft of landside levee toe obstructs access and visibility.

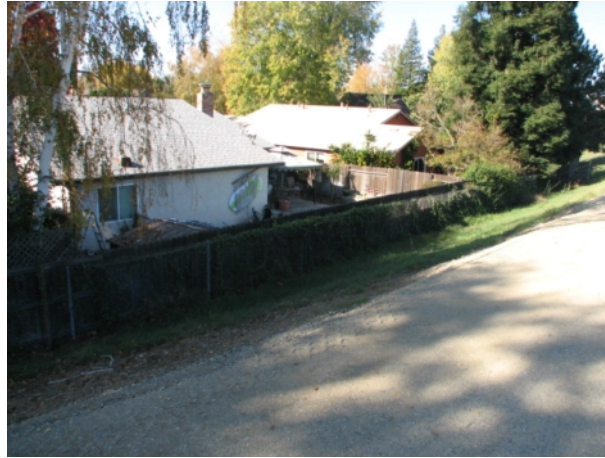
jpaasch_20091119_237.jpg

Wood privacy fence is within 10-ft of the levee toe.

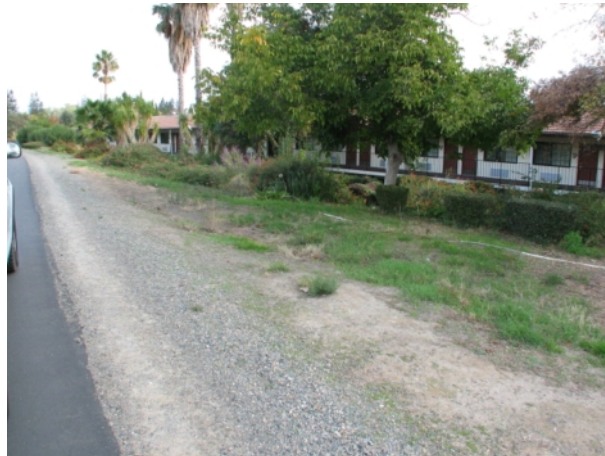
Levee Mile Report Line	3
Start Levee Mile	0.12
End Levee Mile	0.14
Location	Land Side
Category	Earthen Levee
Item	Encroachments
Landscaping on landside slope and within 10-ft of the toe limits access and visibility.	
jpaasch_20091109_188.jpg

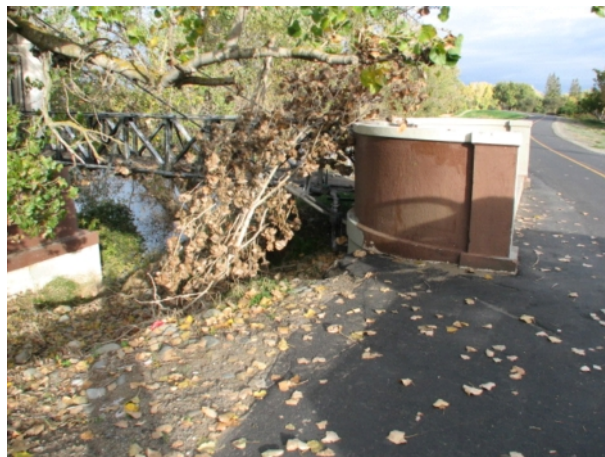
Levee Mile Report Line	4
Start Levee Mile	0.19
End Levee Mile	0.19
Location	Land Side
Category	Earthen Levee
Item	Encroachments
Fallen tree limb on the waterside slope needs to be removed.	
jpaasch_20091109_189.jpg

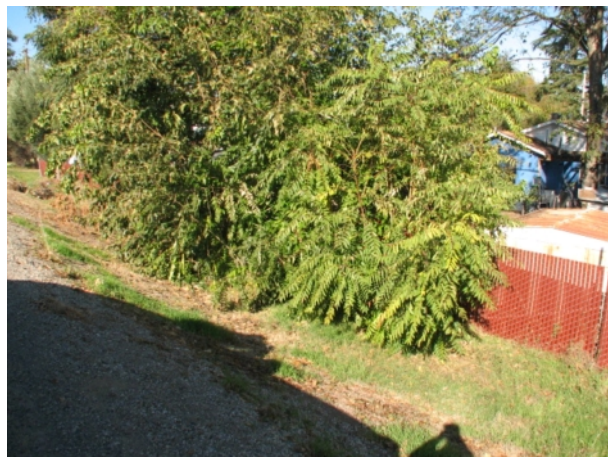
Levee Mile Report Line	15
Start Levee Mile	1.62
End Levee Mile	1.62
Location	Land Side
Category	Earthen Levee
Item	Encroachments
Privacy fence and landscaping within 10-ft of the levee toe obstructs visibility and access.	
jpaasch_20091104_160.jpg

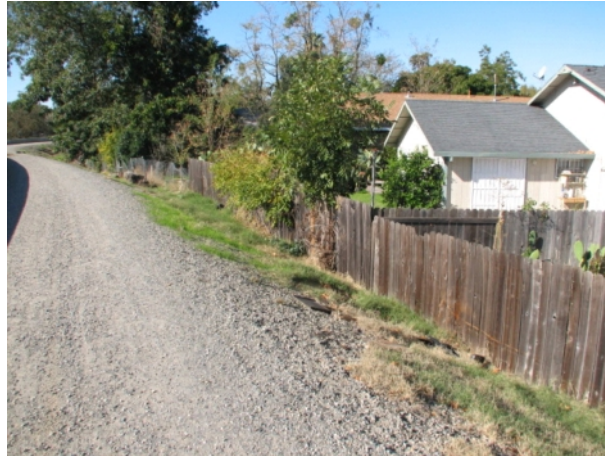
Levee Mile Report Line	17
Start Levee Mile	1.64
End Levee Mile	1.64
Location	Land Side
Category	Earthen Levee
Item	Encroachments
Privacy fence within 10-ft of the levee toe obstructs visibility and access.	
jpaasch_20091104_159.jpg

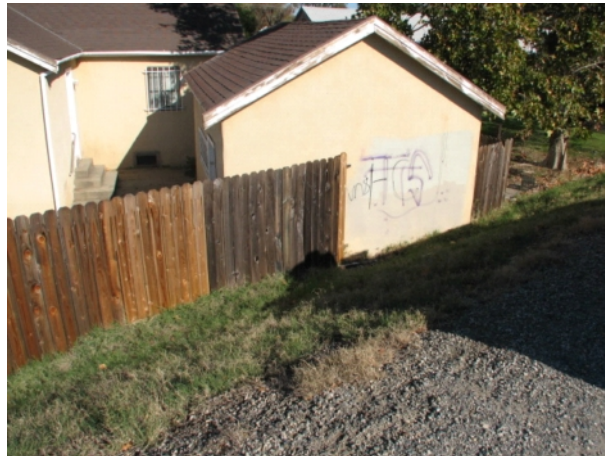
Levee Mile Report Line	20
Start Levee Mile	1.69
End Levee Mile	1.69
Location	Land Side
Category	Earthen Levee
Item	Encroachments
Privacy fence and building within 10-ft of the levee toe obstructs visibility and access.	
jpaasch_20091104_158.jpg

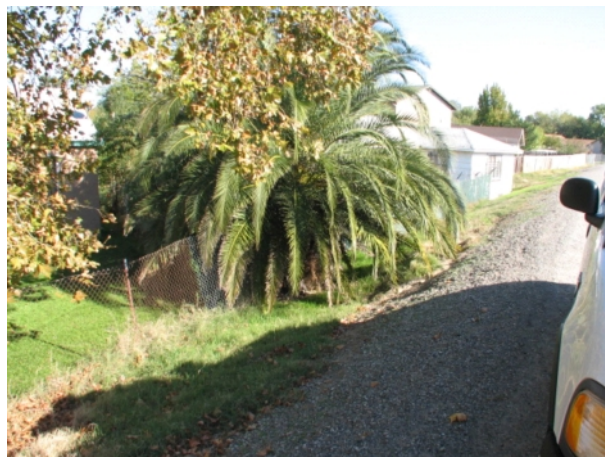
Levee Mile Report Line	21
Start Levee Mile	1.70
End Levee Mile	1.70
Location	Land Side
Category	Earthen Levee
Item	Encroachments
Palm tree within 10-ft of the levee toe obstructs visibility and access.	
jpaasch_20091104_157.jpg

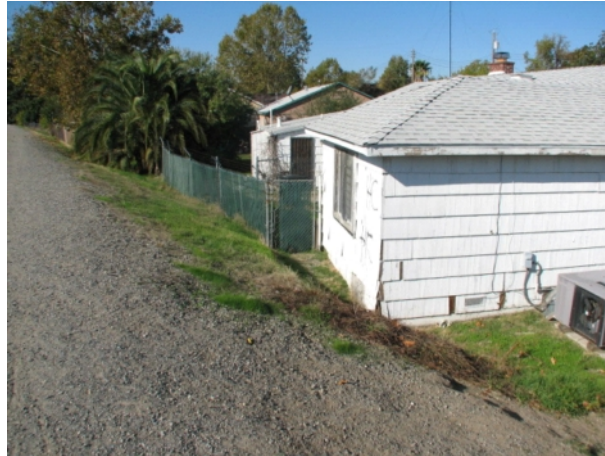
Levee Mile Report Line	22
Start Levee Mile	1.72
End Levee Mile	1.72
Location	Land Side
Category	Earthen Levee
Item	Encroachments
Privacy fence and structure within 10-ft of the levee toe obstructs visibility and access.	
jpaasch_20091104_156.jpg

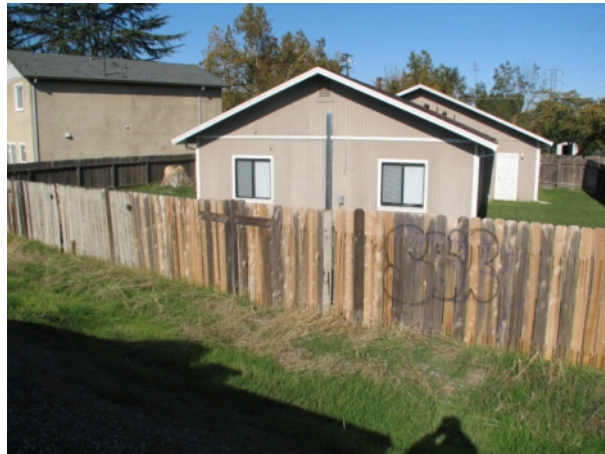
Levee Mile Report Line	24
Start Levee Mile	1.74
End Levee Mile	1.74
Location	Land Side
Category	Earthen Levee
Item	Encroachments
Privacy fence within 10-ft of the levee toe obstructs visibility and access.	
jpaasch_20091104_155.jpg

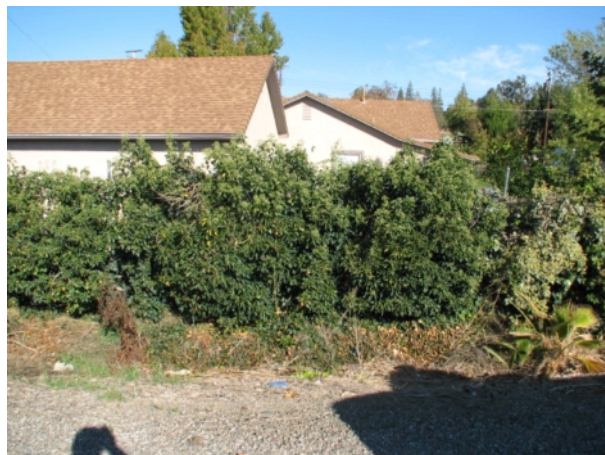
Levee Mile Report Line	25
Start Levee Mile	1.77
End Levee Mile	1.77
Location	Land Side
Category	Earthen Levee
Item	Encroachments
Landscaping within 10-ft of the levee toe obstructs visibility and access.	
jpaasch_20091104_154.jpg

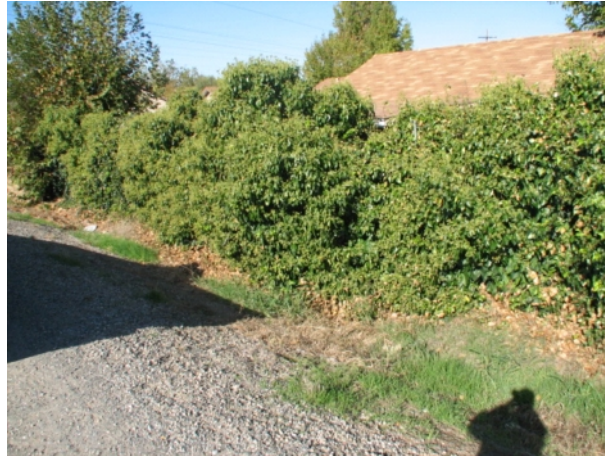
Levee Mile Report Line	26
Start Levee Mile	1.79
End Levee Mile	1.79
Location	Land Side
Category	Earthen Levee
Item	Encroachments
Landscaping and fence within 10-ft of the levee toe obstruct access and visibility.	
jpaasch_20091104_153.jpg

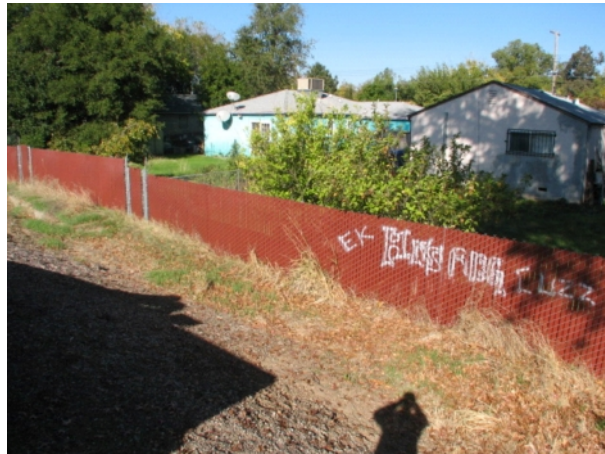
Levee Mile Report Line	29
Start Levee Mile	1.81
End Levee Mile	1.81
Location	Land Side
Category	Earthen Levee
Item	Encroachments
Privacy fence within 10-ft of the levee toe obstructs visibility and access.	
jpaasch_20091104_152.jpg

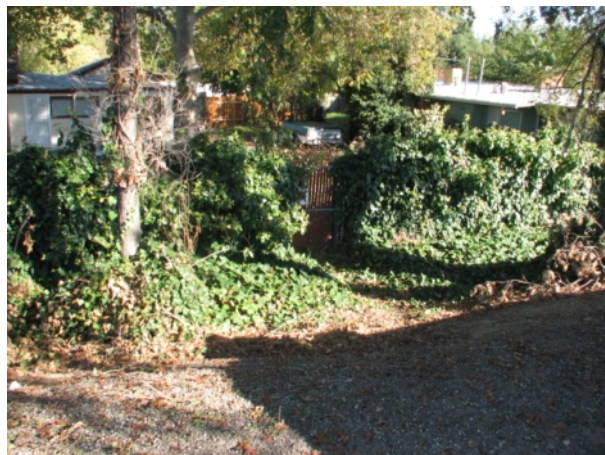
Levee Mile Report Line	30
Start Levee Mile	1.83
End Levee Mile	1.83
Location	Land Side
Category	Earthen Levee
Item	Encroachments
Dense ivy and fence obstruct visibility and access.	
jpaasch_20091104_151.jpg

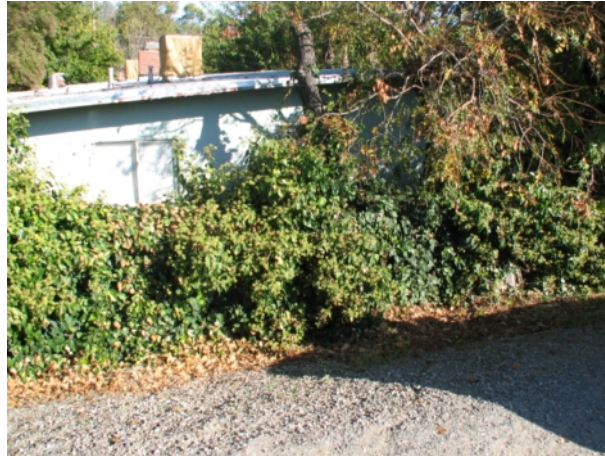
jpaasch_20091104_150.jpg

Building, fence and landscaping are within 10-ft of the levee toe.

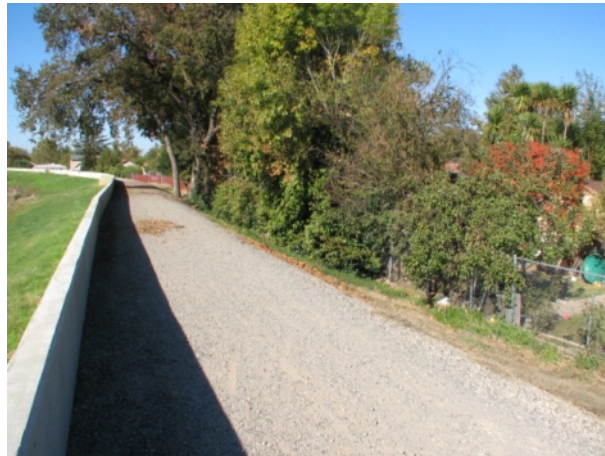
jpaasch_20091104_149.jpg

Levee Mile Report Line	32
Start Levee Mile	1.85
End Levee Mile	1.85
Location	Land Side
Category	Earthen Levee
Item	Encroachments

Wooden shed and landscape plantings are within 10-ft of the levee toe.

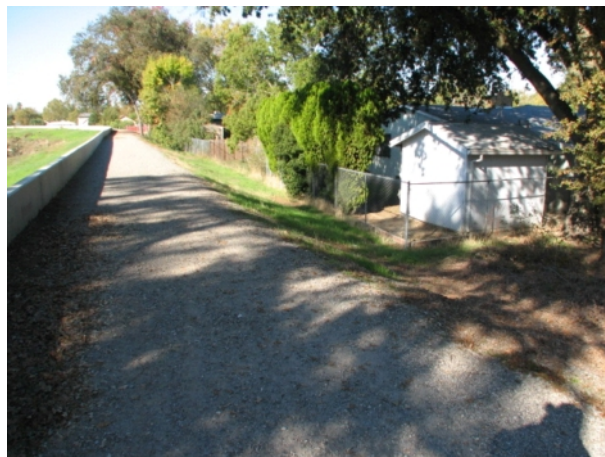
jpaasch_20091104_148.jpg

Levee Mile Report Line	33
Start Levee Mile	1.88
End Levee Mile	1.88
Location	Land Side
Category	Earthen Levee
Item	Encroachments

Building, fence and trees are within 10-ft of levee toe.

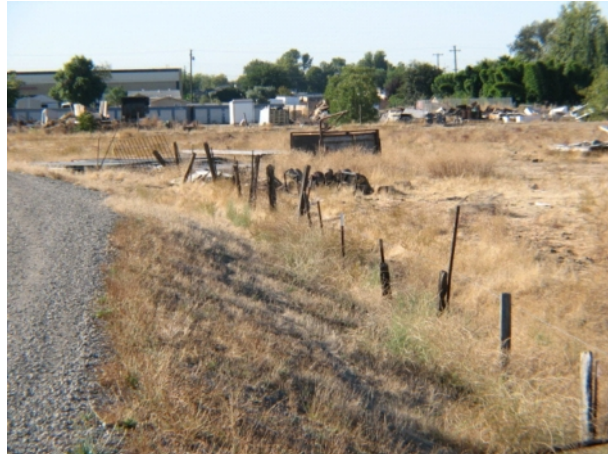
6	1.26	1.32	Earthen Levee	Encroachments	LS	PO	Fences Inspector Comments: Barbed wire fence runs along the levee toe.	38.662672 ° -121.431672 °	38.661823 ° -121.431678 °	2 Y
7	1.35	1.35	Earthen Levee	Encroachments	LS	M	Debris Inspector Comments: Rusty metal sheets located within landside drainage area.	38.661665 ° -121.431343 °	38.661665 ° -121.431343 °	1

Levee Mile Report Line	6
Start Levee Mile	1.26
End Levee Mile	1.32
Location	Land Side
Category	Earthen Levee
Item	Encroachments
Barbed wire fence on levee toe.	
jpaasch_20091002_1.jpg
